Manhole Inspection Summary

Manhole # S11MM_007MH

Insp Date: **7/25/08 10:58 AM**

Location Address: **3001 ELGIN AVE**

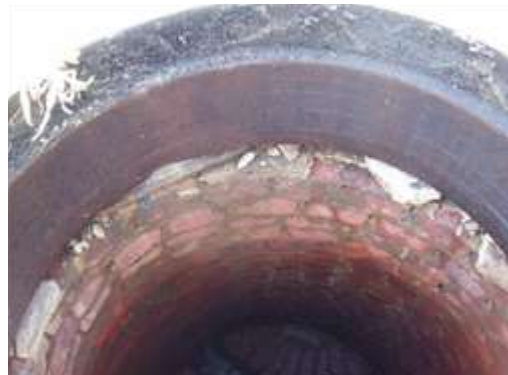
Defect 1

Condition: ☐ Sound ☐ Cracked ☐ Root Intrusion ☐ Loose Brick ☒ **Deteriorated**

CHIMNEY DETERIORATED.

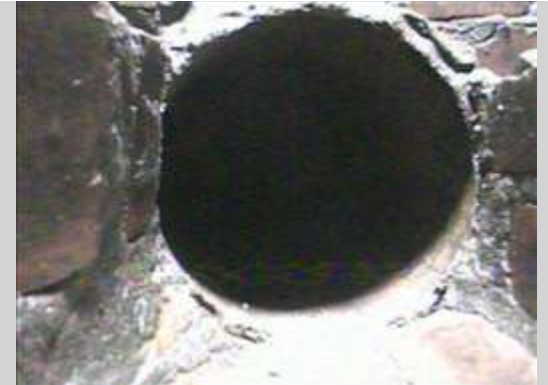
12 O'Clock Outflow

8 in. Circular Gravity Sewer
Pipe Out @ 12 O'Clock

Pipe Height: (in.) Direct
Pipe Material: **Clay** ☐ Pipe Lined
Invert Depth: **8.69** (ft.) Flow Characteristics: **Slow**
Deposits: ☒ None ☐ Mud ☐ Sludge ☐ Debris ☐ Grease
Silt Depth: (in.) Deposits Extent:
Infiltration: **None** Pipe Seal Cond: **Sound**

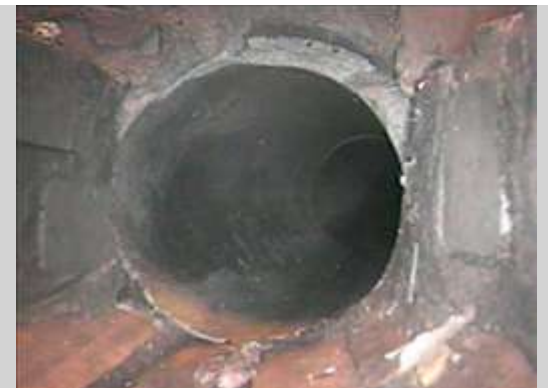
3 O'Clock Inflow

8 in. Circular Gravity Sewer
Pipe In @ 3 O'Clock

Pipe Height: (in.) Direct
Pipe Material: **Clay** ☐ Pipe Lined
Invert Depth: **8.72** (ft.) Flow Characteristics: **Slow**
Deposits: ☒ None ☐ Mud ☐ Sludge ☐ Debris ☐ Grease
Silt Depth: (in.) Deposits Extent:
Infiltration: **None** Pipe Seal Cond: **Broken**
